# Asphalt Pavement Forensics: Understanding the Problem to Better Determine the Solution

63<sup>rd</sup> Annual Asphalt Paving Conference  
FireKeepers Casino Hotel  
Battle Creek, Michigan  
March 6-7, 2019

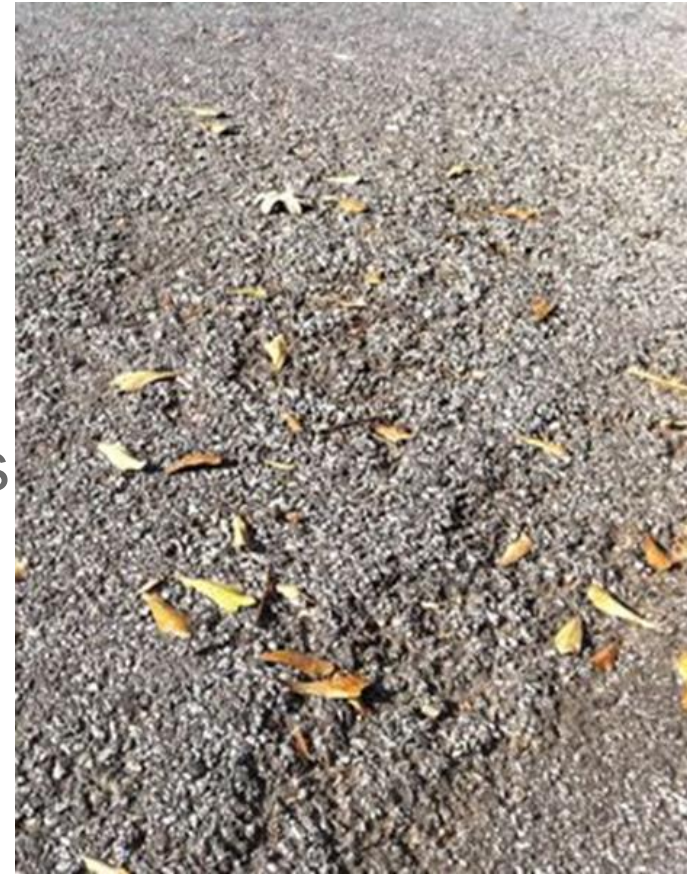
# Surface Defects - Raveling

- Wearing away of the pavement surface. Caused by the dislodging of aggregate and the loss of asphalt binder.
- Ranges from loss of fines to loss of coarse aggregate.
- Ultimately leads to a very rough and pitted surface.

- Insufficient asphalt content (film thickness)
- Stripping of asphalt film on aggregates
- Age-hardening of asphalt
- Poor compaction
- The presence of raveling indicates potential mixture-related performance problems.

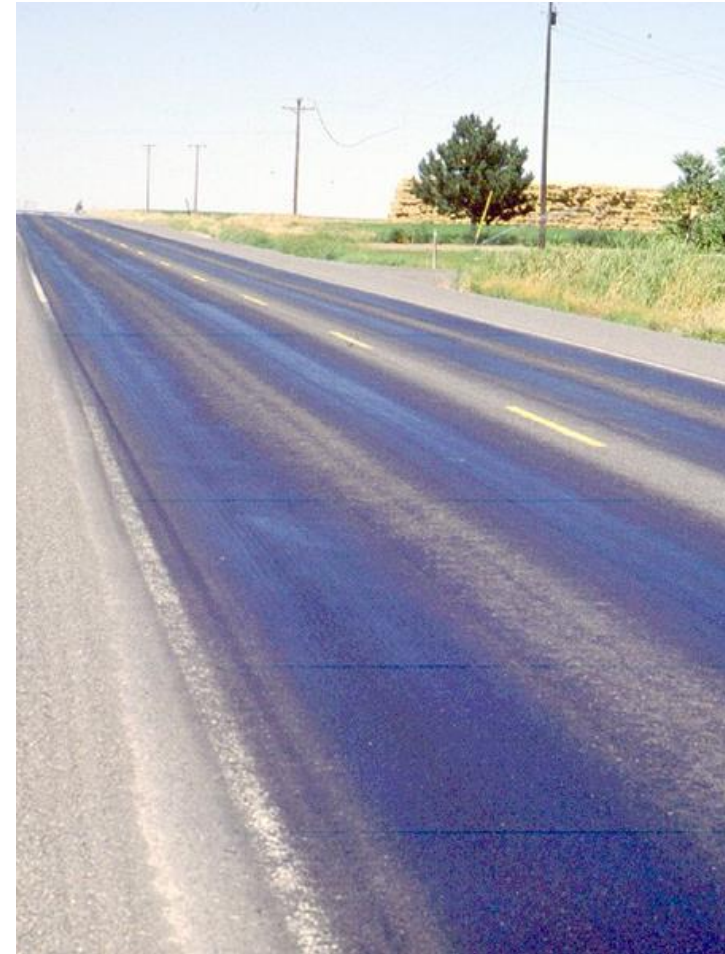
# Surface Defects - Flushing

- Excess bituminous material occurring on the pavement surface. Usually found in the wheel paths of traffic movements
- Ranges from surface discoloration relative to the remainder of the pavement.

- The presence of flushing indicates potential mixture-related performance problems
- Poor initial mix design properties
- Paving or Sealcoating over an already severely flushed surface

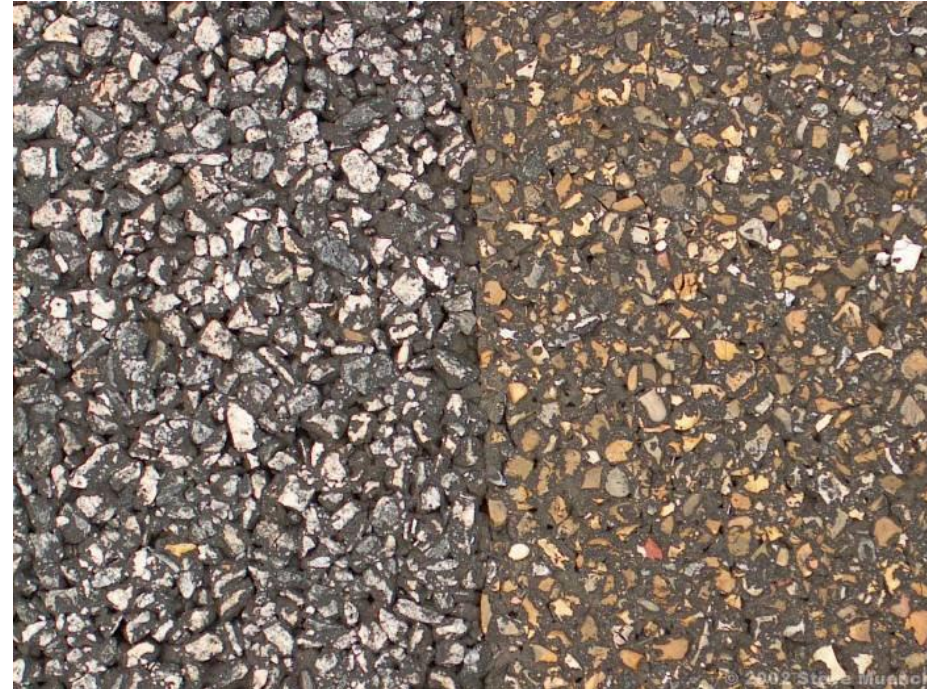
# Surface Defects - Polishing

- Surface binder worn away thus allowing sharp edges of aggregates to be smoothed or polished

- Wearing away of asphalt film from aggregate
- Low asphalt content (film thickness)
- Mix design properties
- Soft or non-skid-resistant aggregates

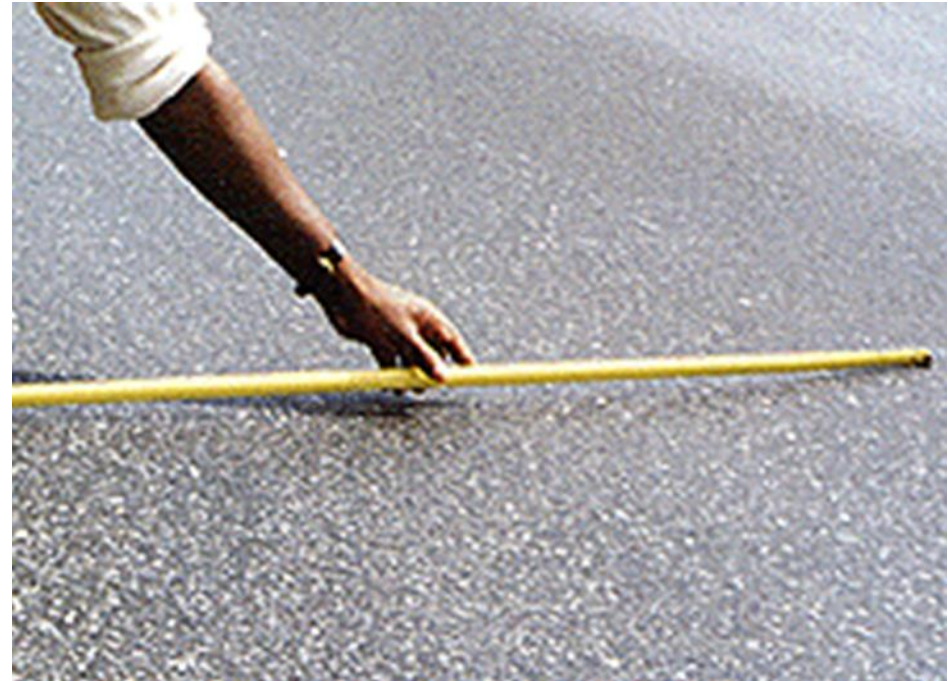
# Surface Deformation - Rutting

- Longitudinal surface depression in the wheel path.
- It may have associated transverse displacement.

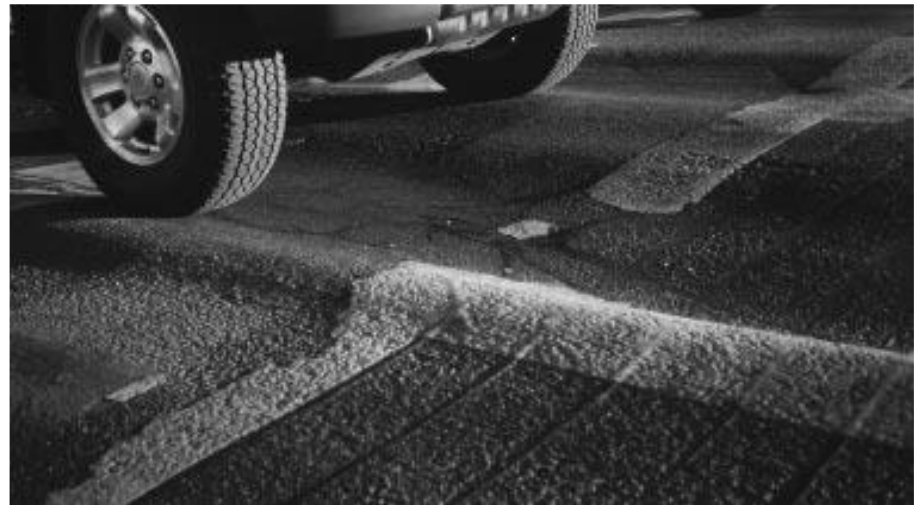
- Severity levels could be defined by categorizing the measurements taken
- Record average depths to the nearest inch
  - Slight: less than 1/2”
  - Moderate: 1/2” – 2”
  - Severe: greater than 2”

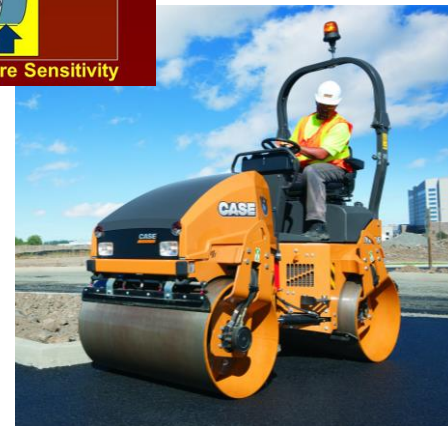
## Possible Causes

- Mix design properties (unstable mixture)
- Lack of initial compaction
- Base and/or Subgrade consolidation
- Potential drainage problems in subsurface
- Can be combination of these!

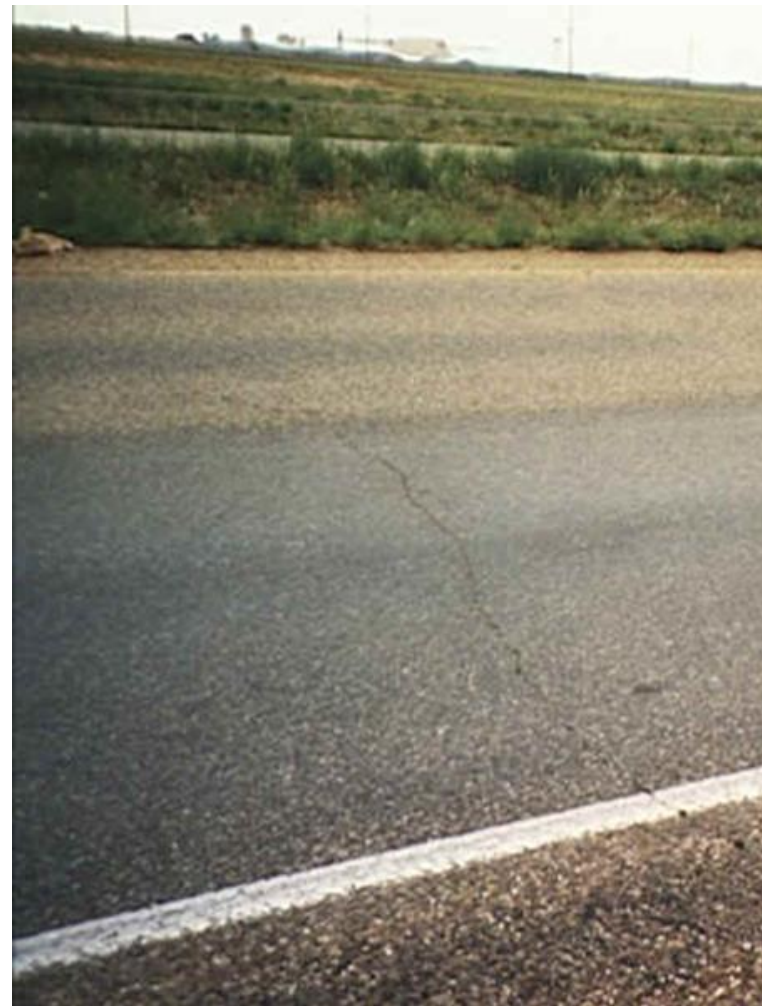
# Cracking – Transverse

- Cracks at approximate right angles to center line
- Often regularly spaced
- Typically a result of movement due to temperature changes and age-hardening of the asphalt

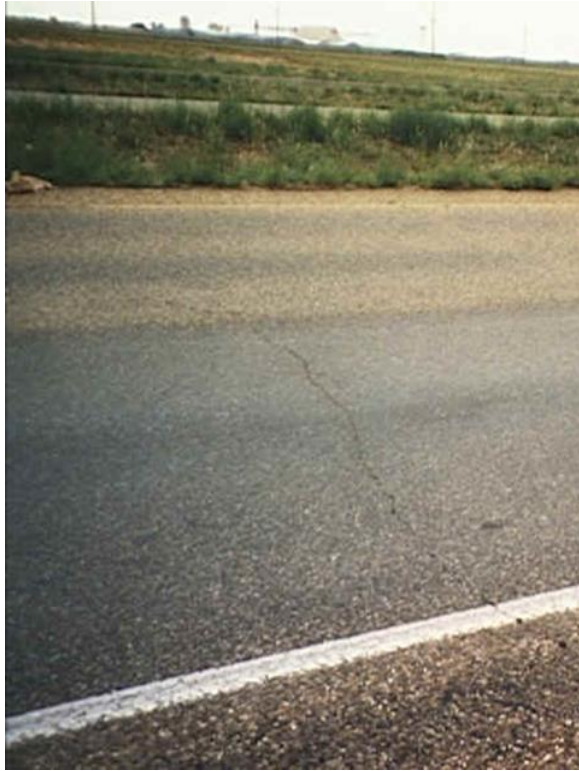
Slight

# Cracking – Transverse

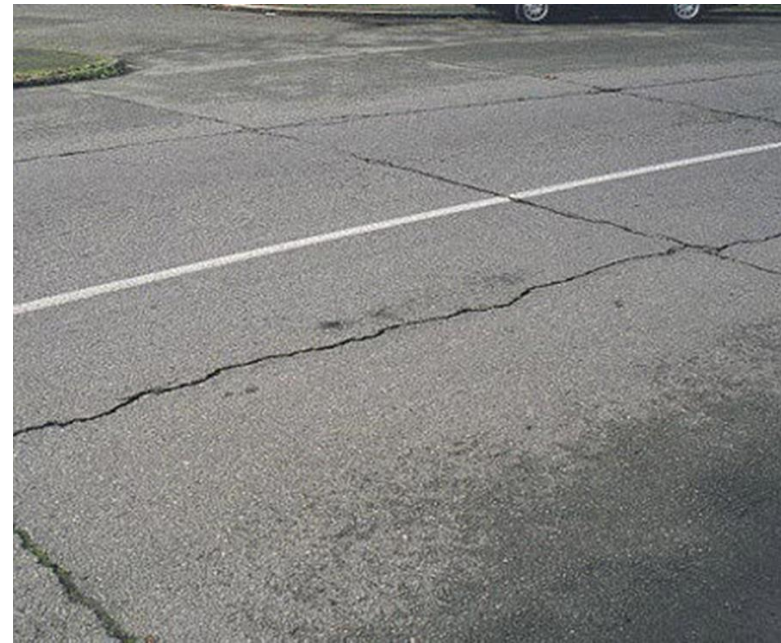
# Cracking - Reflective

- Cracks in asphalt overlay surfaces that “reflect” the crack pattern underneath
- Note: When over PCC joint spacing in the slabs beneath the asphalt overlay must be known in order to identify as reflection cracking at joints

- Typically a result of a thin overlay placed over “working” or active cracks in the existing surface
- Asphalt overlays over failed or cracked PCC pavements

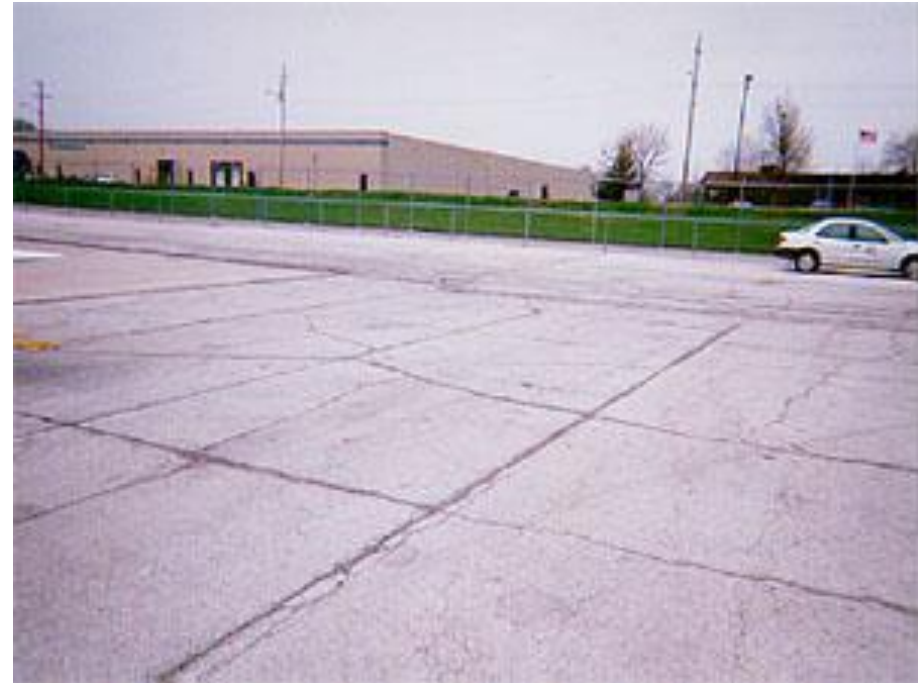
# Cracking - Reflective

## Possible Causes

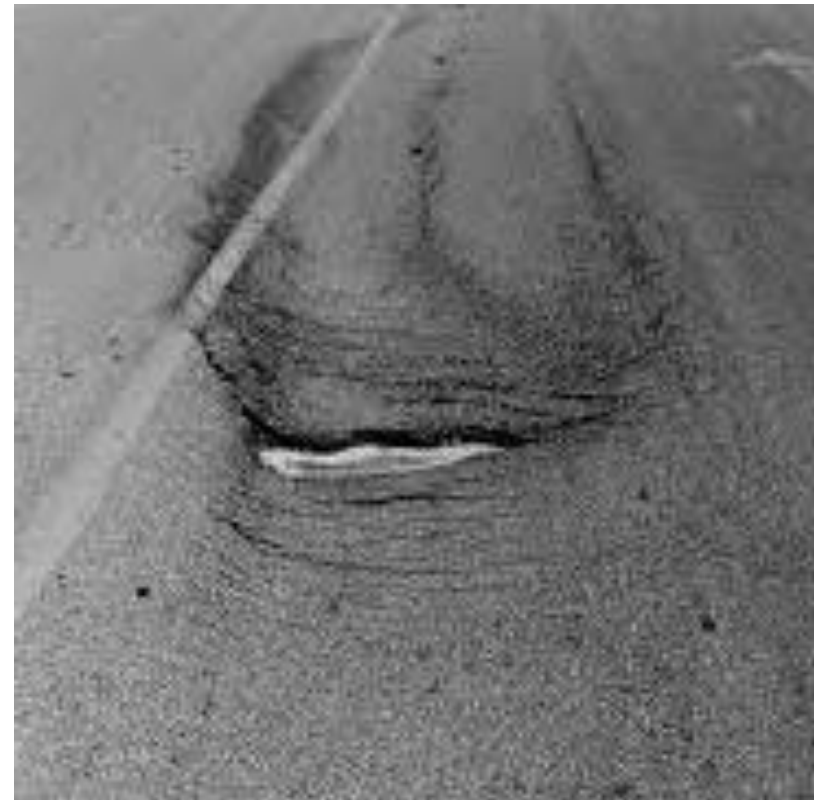
# Cracking - Slippage

- Crescent or rounded cracks in the direction of traffic
- Primarily occurs at areas of the pavement where traffic is stopping and starting

- Slippage between an overlay and an underlying pavement
- Lack of bond between layers (tack coat?)
- Dusty or dirty surface when placing tack

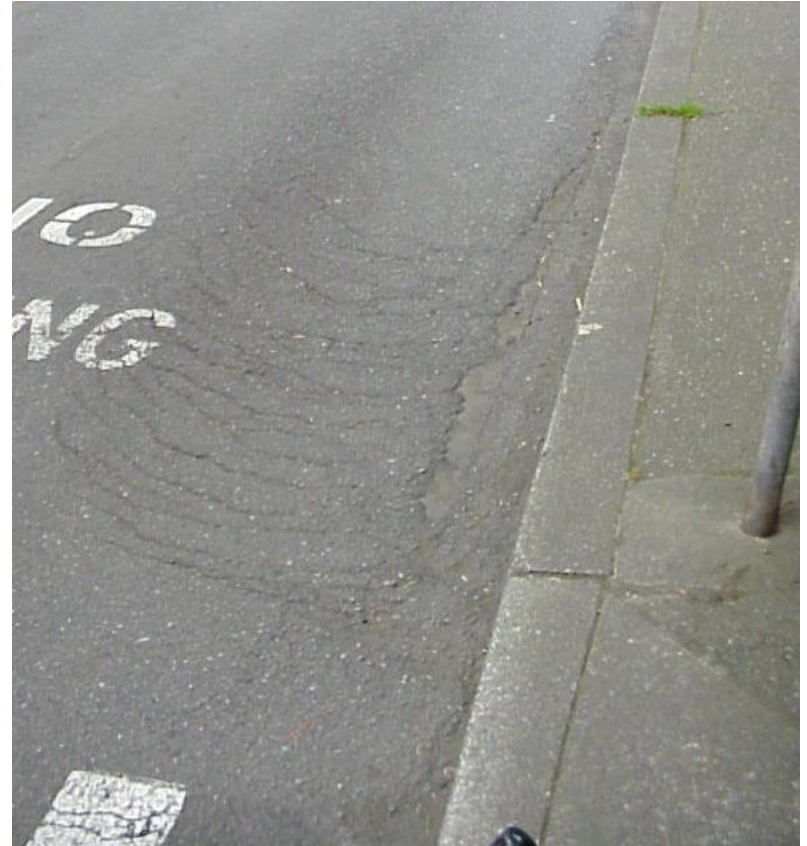
# Cracking - Slippage

## Possible Causes

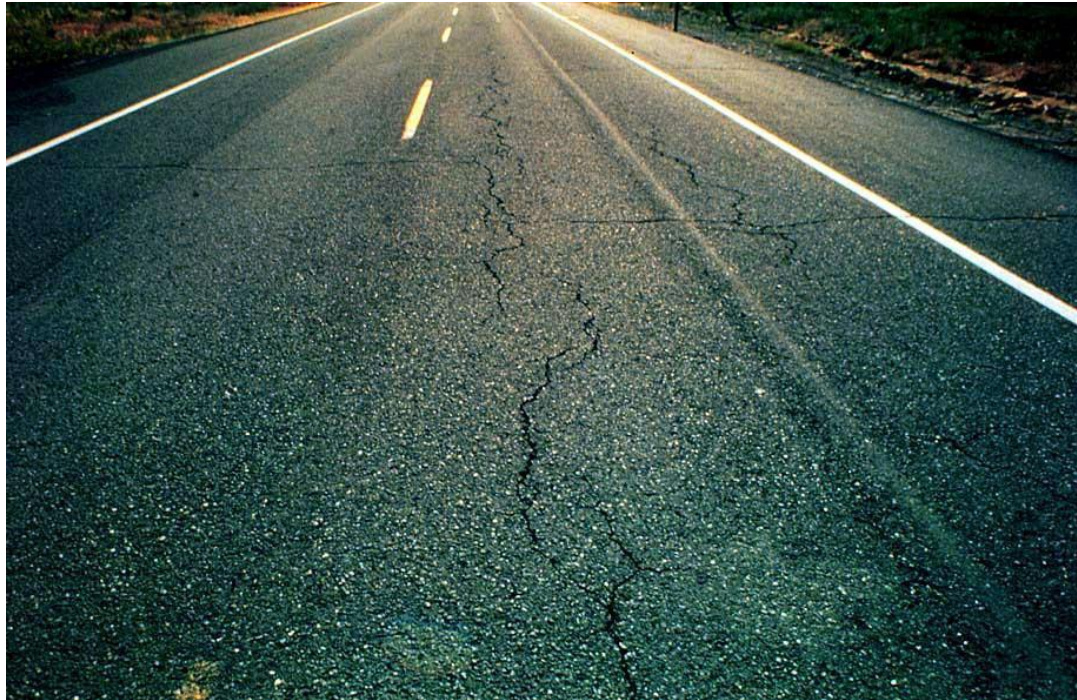
Load Related

# Cracking - Longitudinal

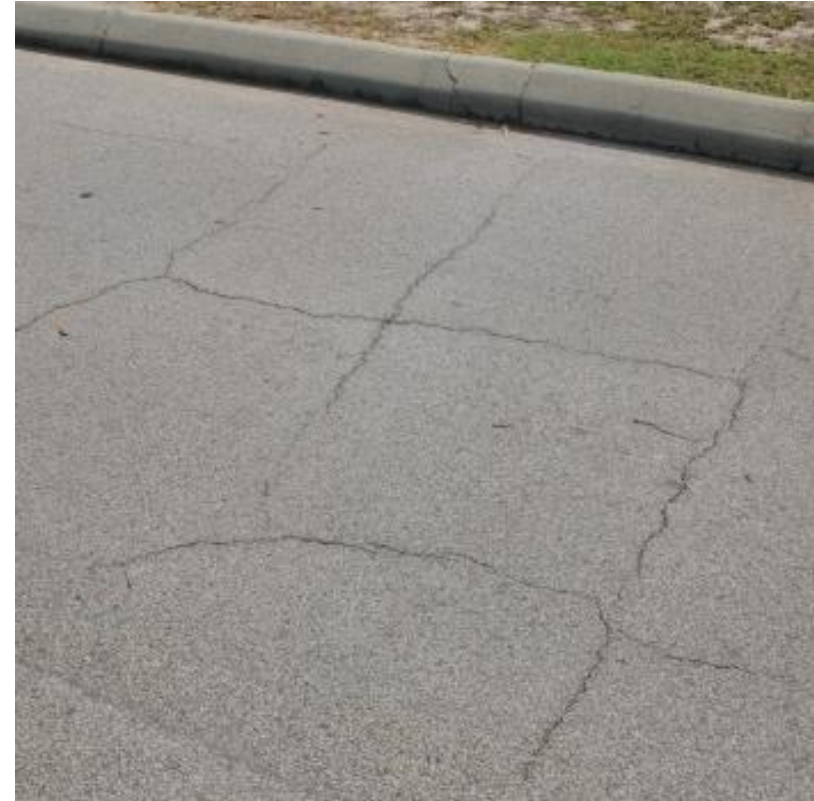
# Cracking - Block

- A cracking pattern that develops into approximately rectangular pieces or blocks.
- Blocks typically range in size from 1 ft. to 10 ft. across
- Typically caused by pavement shrinkage due to environmental factors

- Shrinking and hardening of the asphalt over time
- As the asphalt ages and then tries to contract during low temperature cycles, it develops block cracking

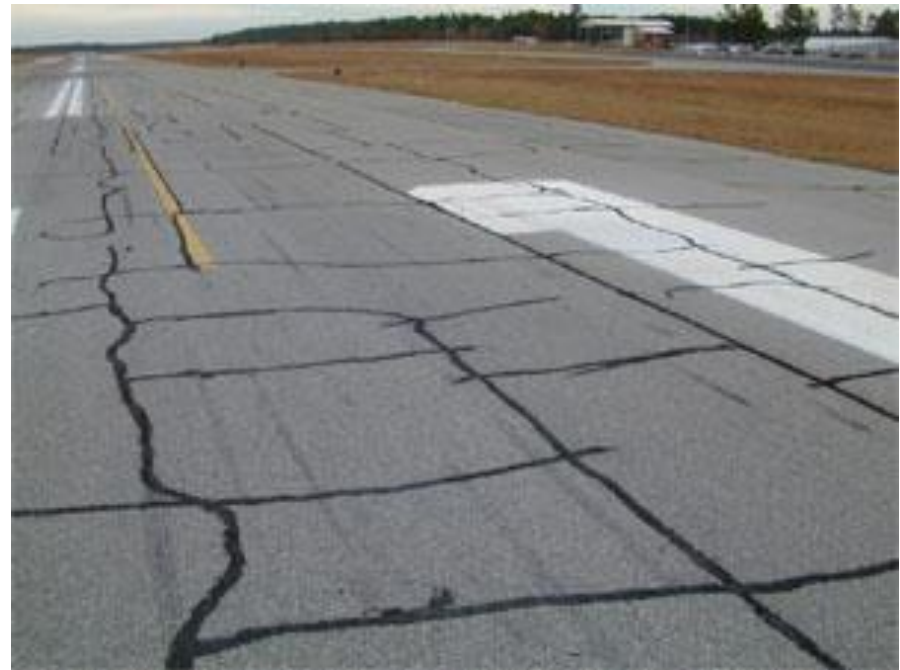
# Cracking - Block

## Possible Causes

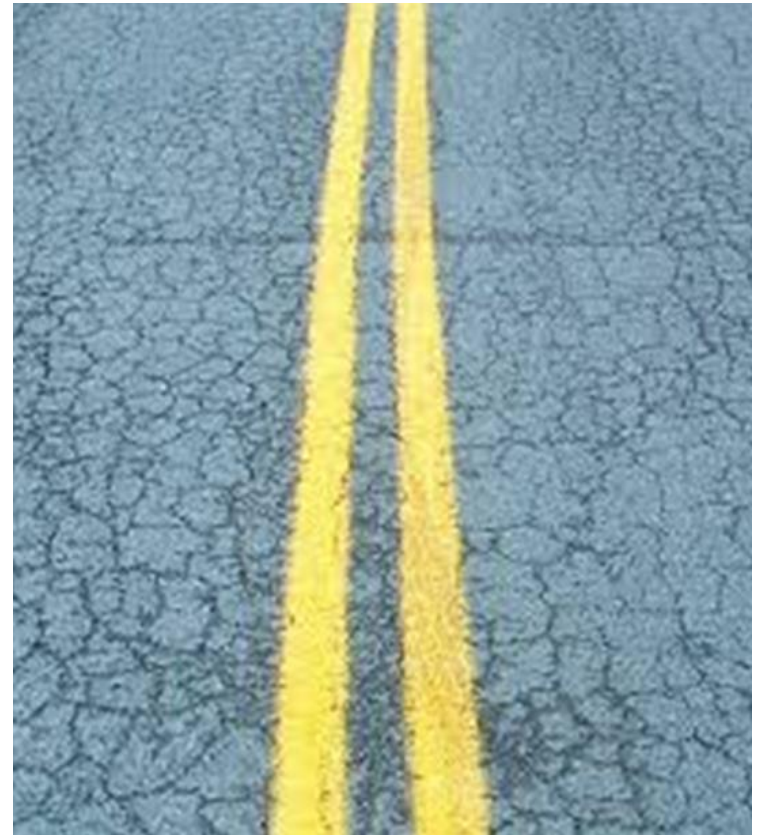
# Cracking – Alligator (Fatigue)

- Normally occurs in areas of repeated traffic loadings (Wheel Paths) but can also be seen in non-wheel path areas.
- Develops into a chicken wire or alligator pattern in later stages.

- Typically caused by inadequate pavement structure for actual traffic loadings
- Lack of base and/or subgrade support

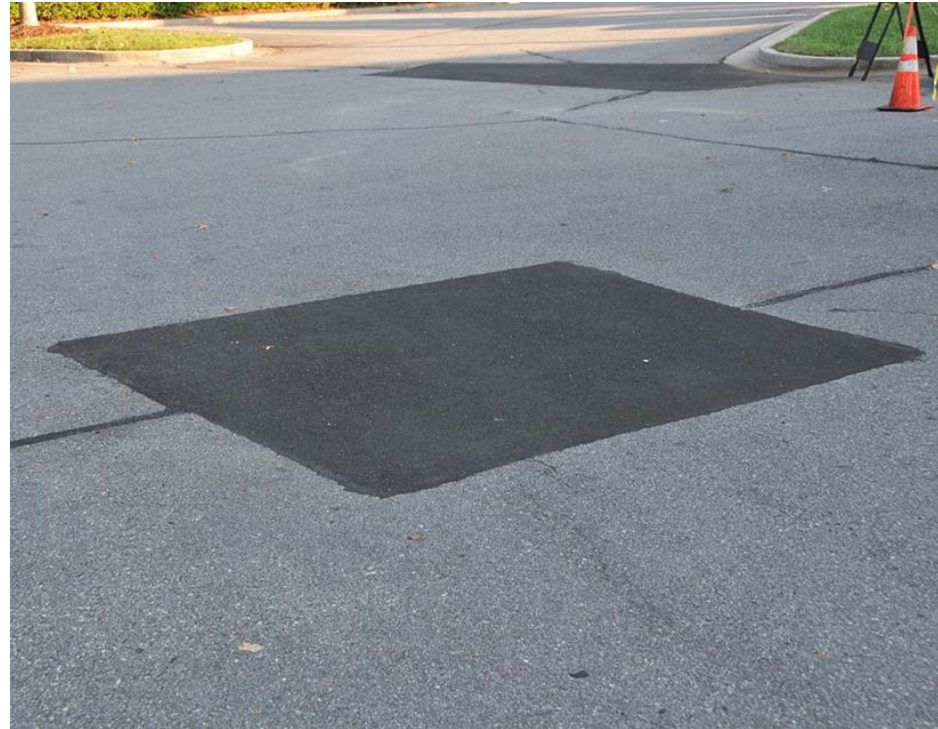
# Patch/Patch Deterioration

- Portion of original pavement surface that has been either removed and replaced or additional material has been applied to the pavement after initial construction.

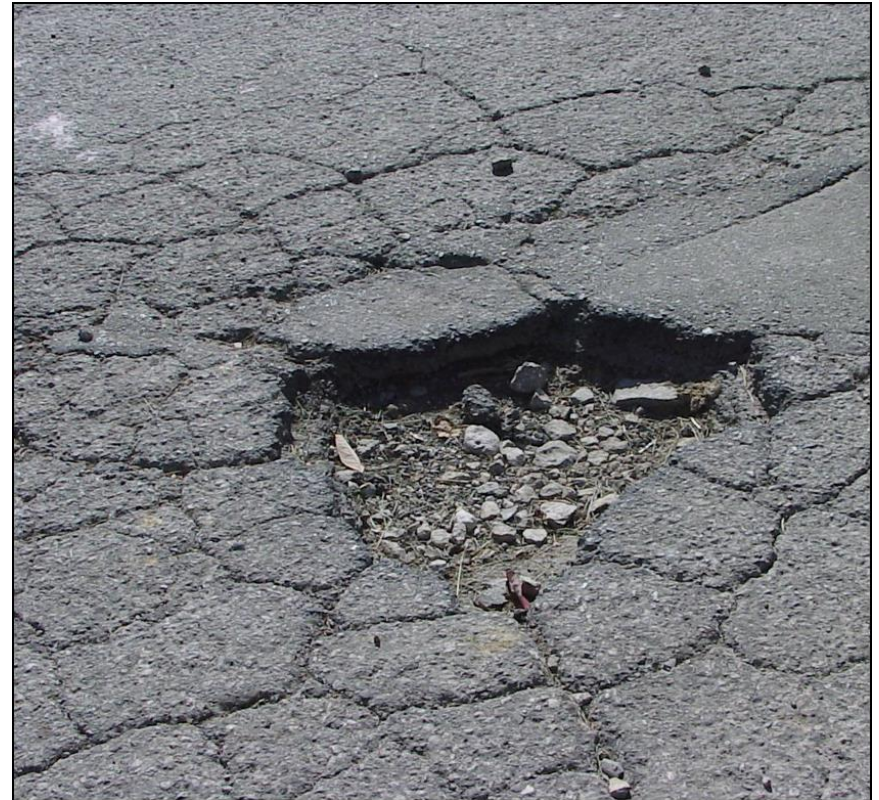
# Potholes

- Bowl-shaped holes of various sizes and shapes in the pavement surface.

- Utility cuts
- Underlying base and/or subgrade support
- Fatigue cracking and/or inadequate pavement strength
- Poor drainage

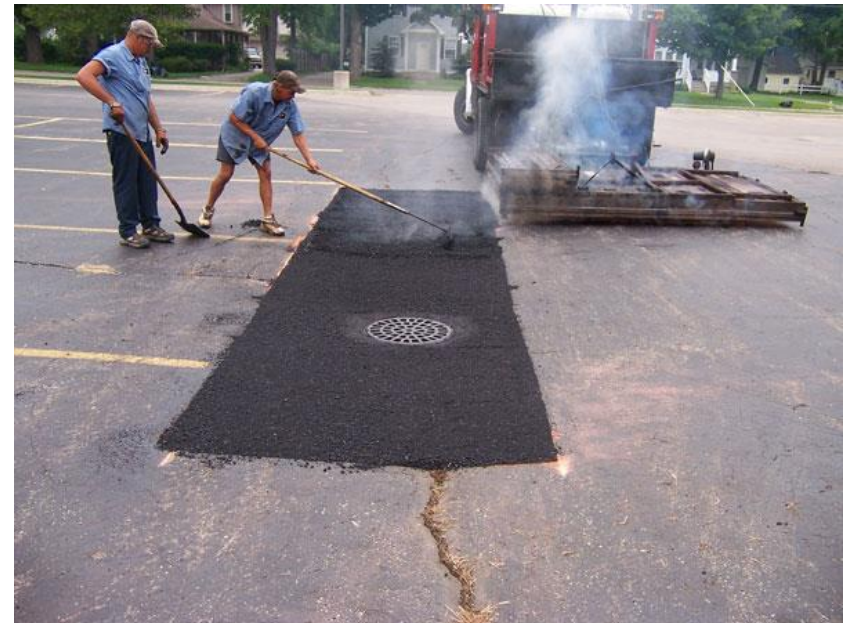
## Possible Causes

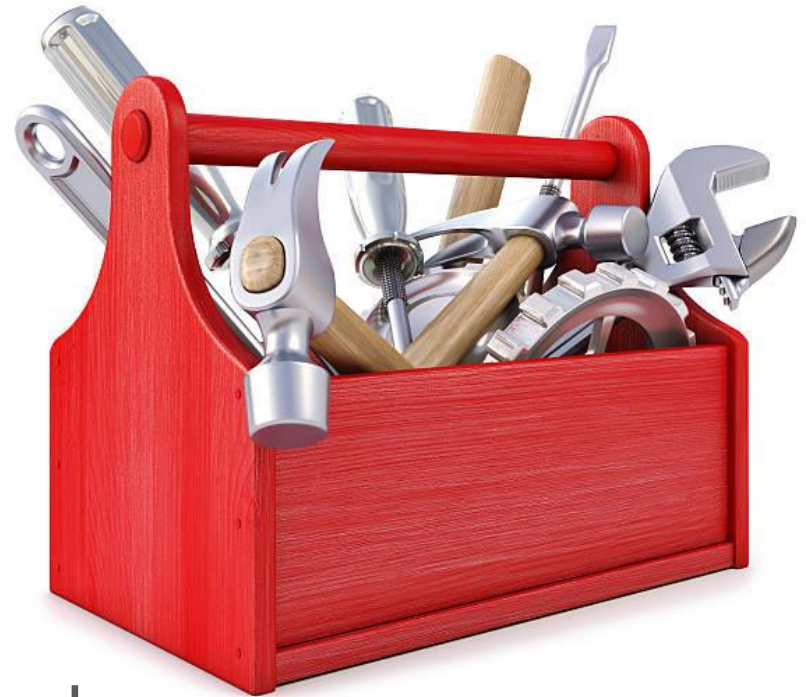
# Forensic Investigations

- “Tools in the Toolbox”
  - Identified Distresses
  - Dry Drilling
  - Wet Coring
  - Trenching
  - Deflections
  - Ground Penetrating Radar

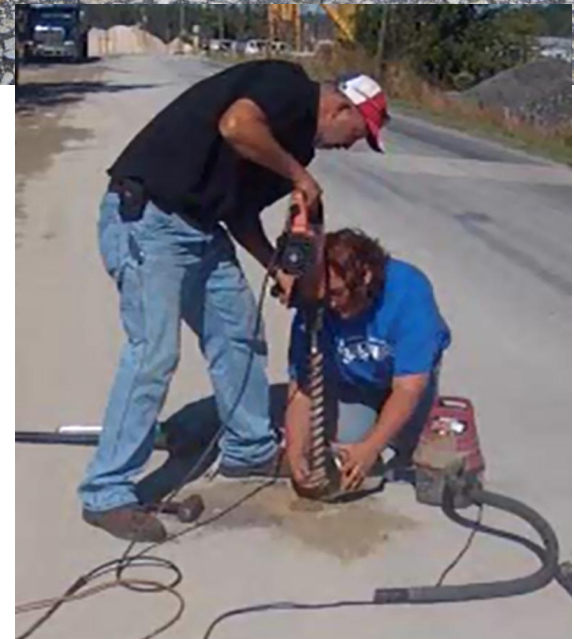
- Dry Drilling
  - Asphalt Thickness
  - Base Material & Thickness
  - Subgrade Depth
  - Moisture/Drainage?

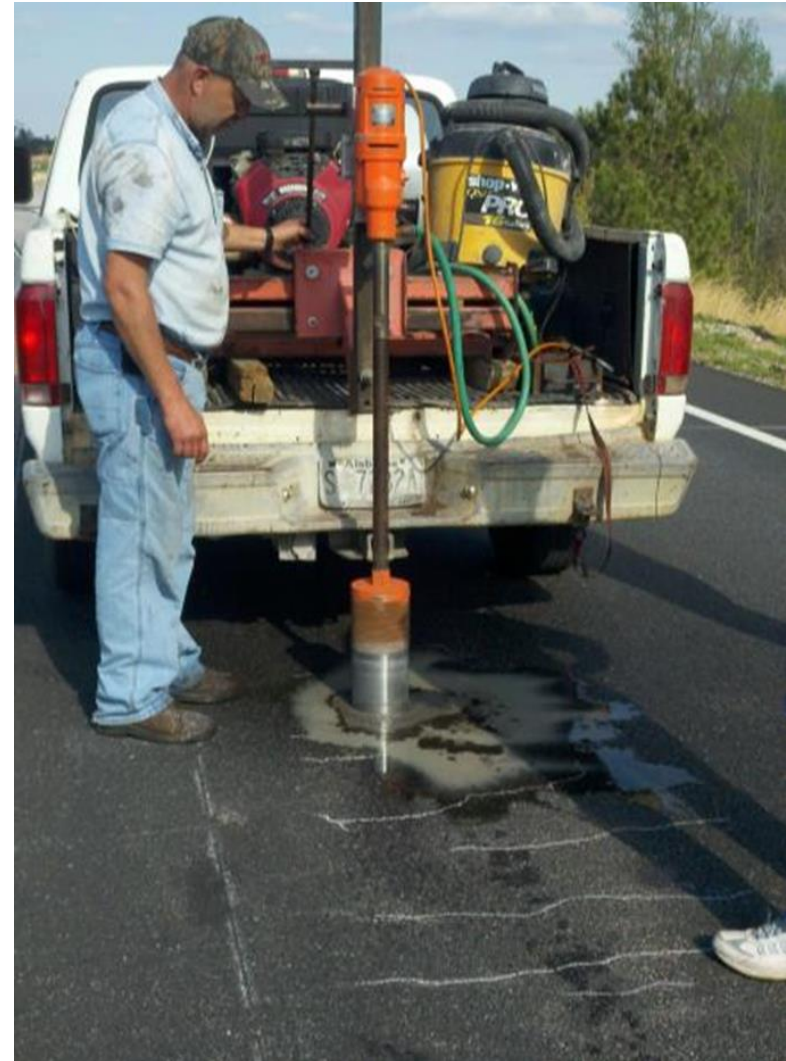
- Wet Coring
  - Layer Thicknesses
  - Crack Type/Depth
  - Stripping
  - De-Bonded Layers
  - Test Specimens
    - Mix Testing
    - Binder Grading
    - Aggregate Quality

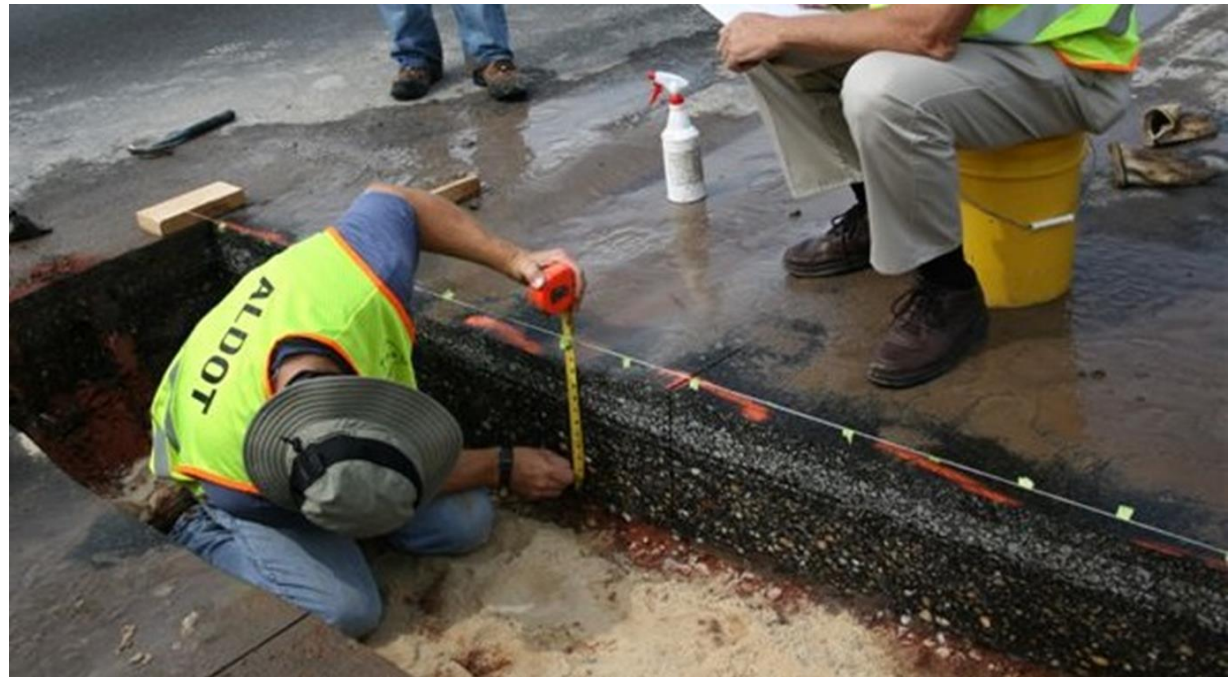
- Trenching
  - Layer Thicknesses
  - Identify Problem Layers
  - Test Specimens

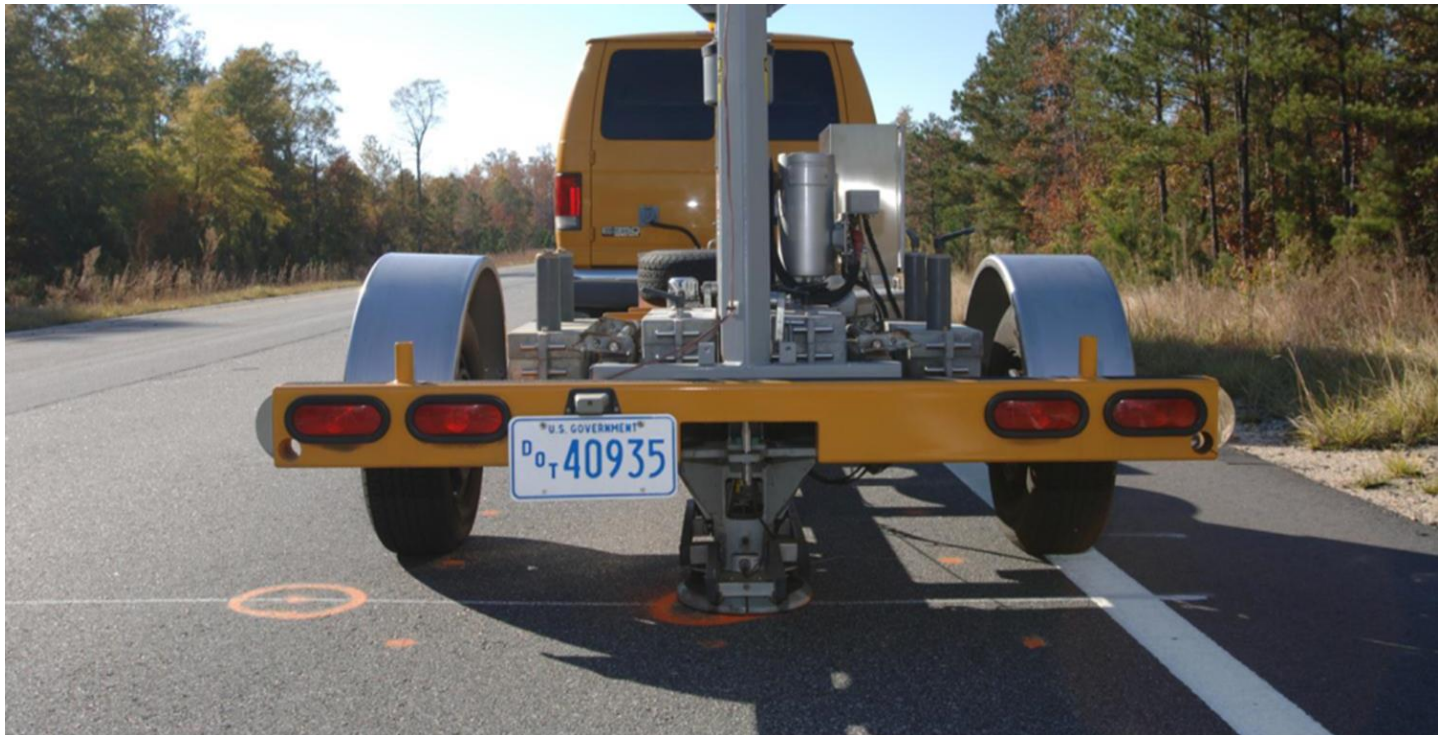
- Deflections
  - Pavement Strength Characteristics
  - De-Bonded layers, stripped layers, etc...

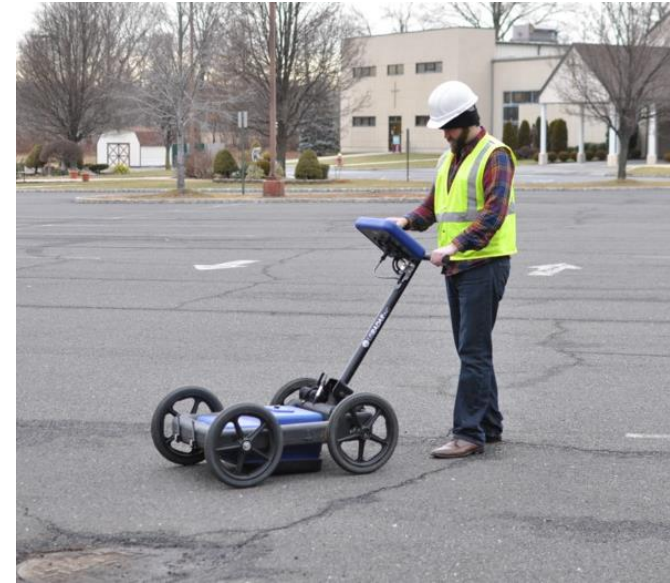
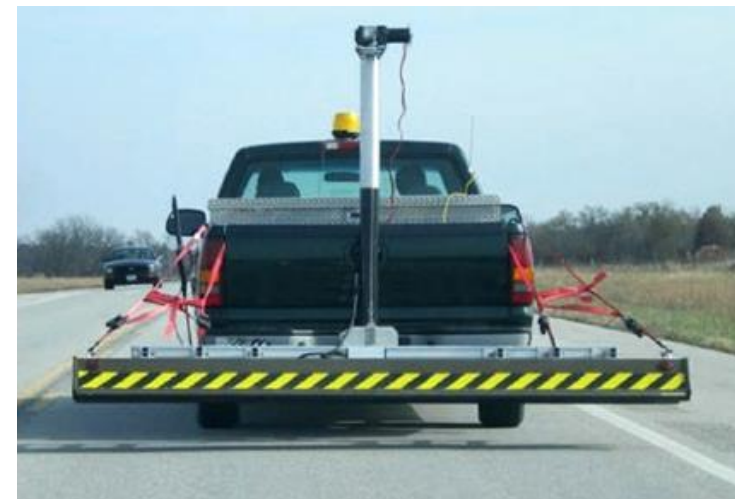
- Ground Penetrating Radar
  - Layer Thicknesses
  - Stripping and/or Layer Separation
  - Subsurface Moisture

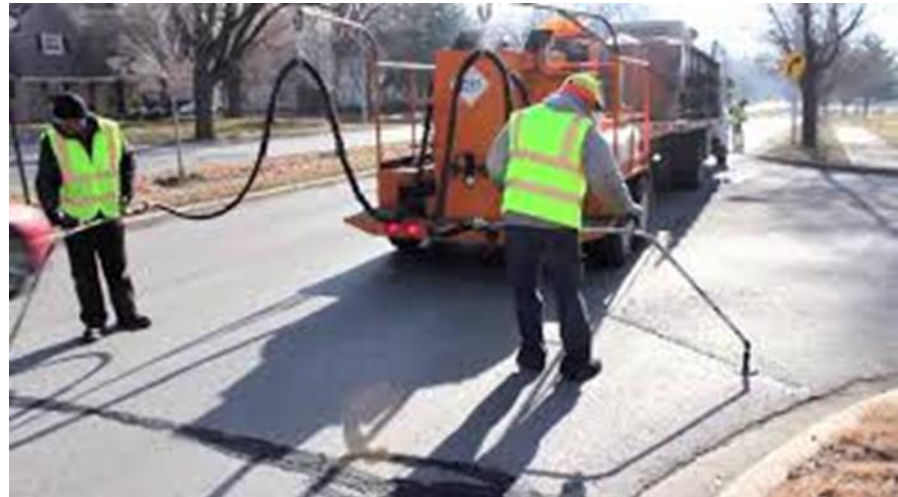
- Crack Sealing/Filling
  - Preserve the intended design life
  - Extend the service life of the existing asphalt concrete by reducing moisture infiltration
  - Prepare the existing pavement prior to construction of an asphalt concrete overlay

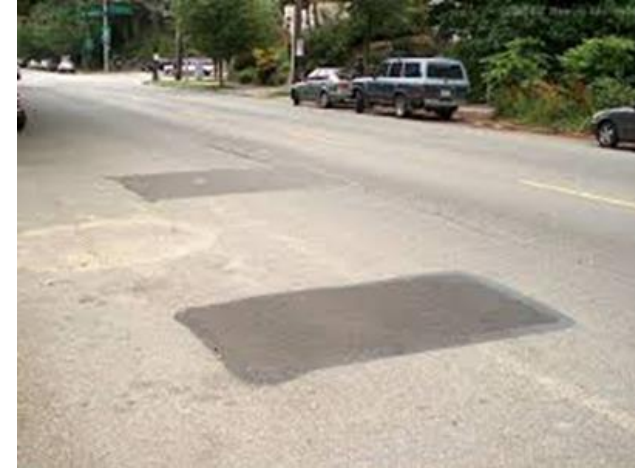
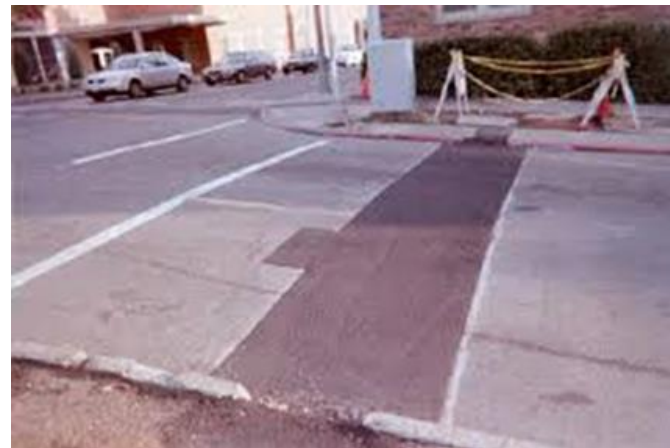
- Patching

- Repair localized distress
- Improve motorist safety
- Reduce pavement roughness
- Reduce rate of deterioration
- Repair pavement prior to overlay
- Utility cuts

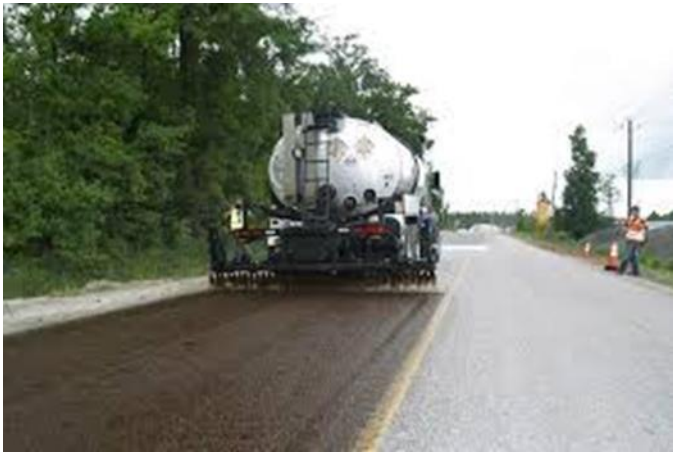
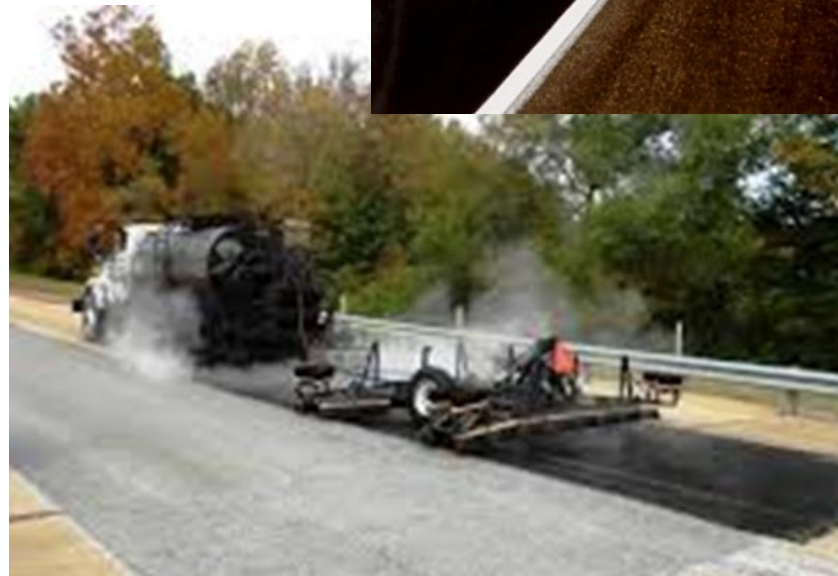
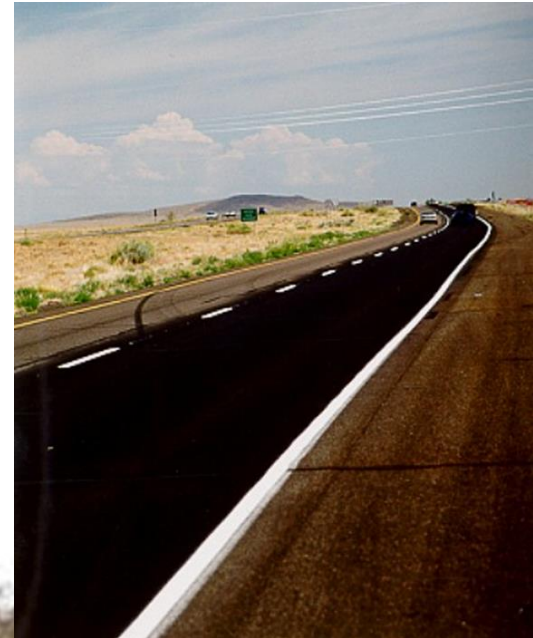
# Corrective Actions

- Surface Treatments
  - Fog Seals
  - Sand Seals
  - Scrub Seals

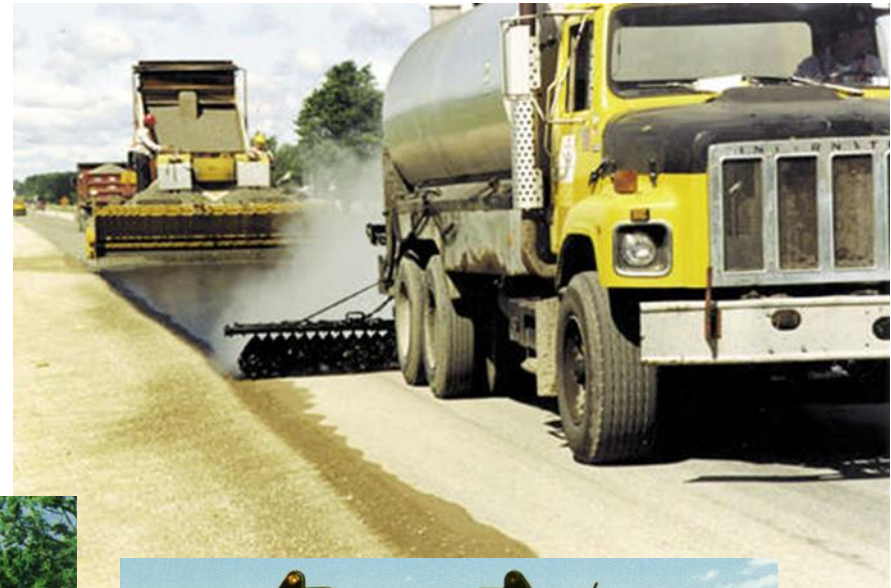
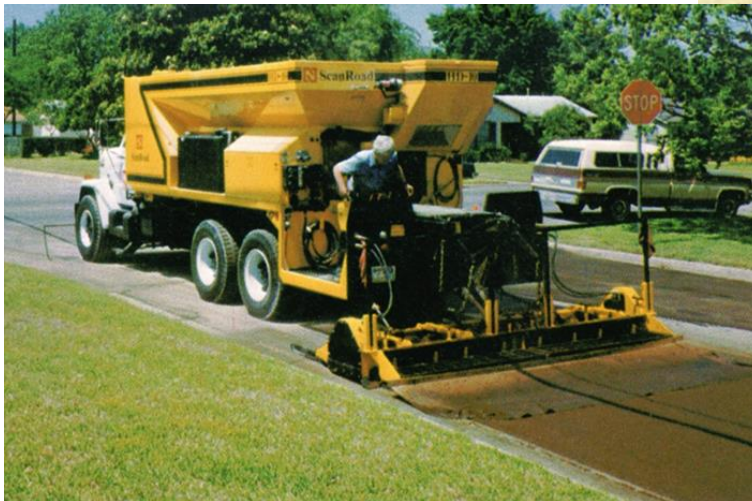
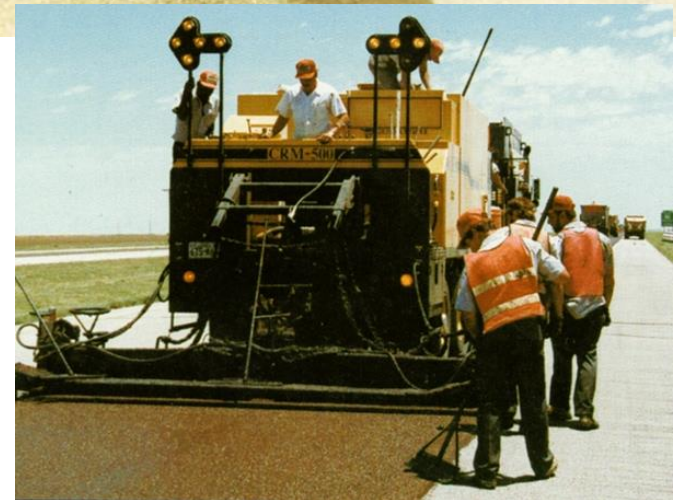
# Corrective Actions

- Surface Treatments
  - Chip Seals
  - Slurry Seals
  - Micro-Surfacing

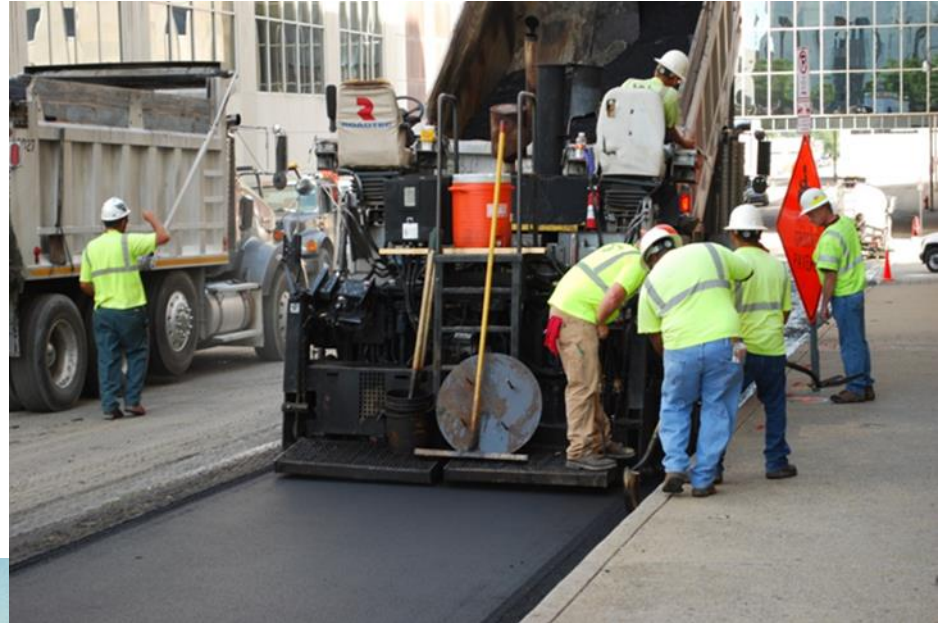
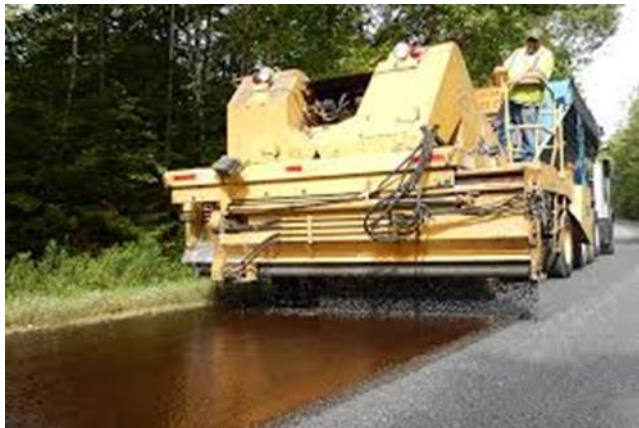
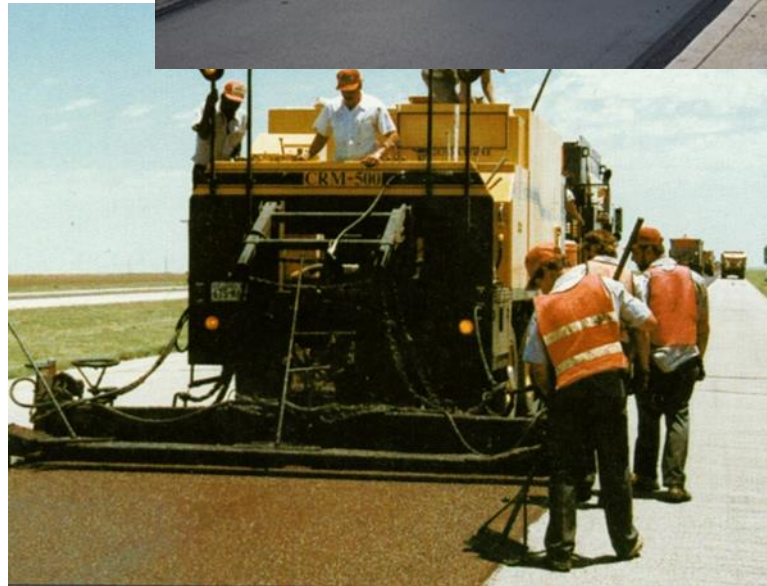
# Corrective Actions

- Surface Treatments
  - Thinlay Asphalt
  - Sandwich Seals
  - Cape Seals

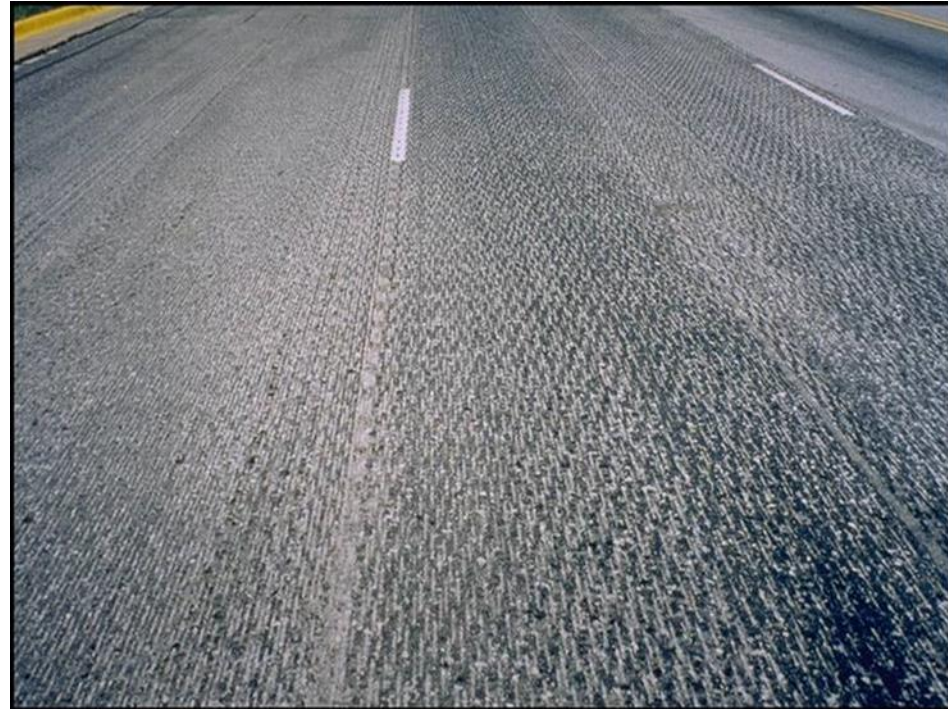
- Mill & Inlay
  - Removal of rutting
  - Removal of distressed layer
  - Restore curb line
  - Restore cross slope
  - Restore surface friction
