# Asphalt Pavement Forensics: Understanding the Problem to Better Determine the Solution

63<sup>rd</sup> Annual Asphalt Paving Conference  
FireKeepers Casino Hotel  
Battle Creek, Michigan  
March 6-7, 2019

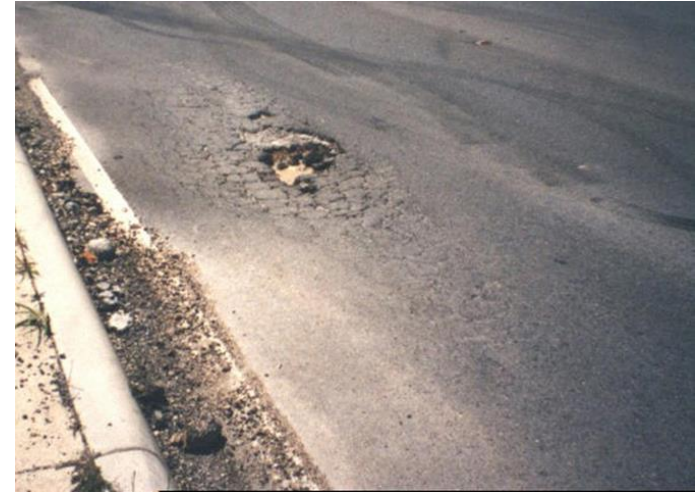
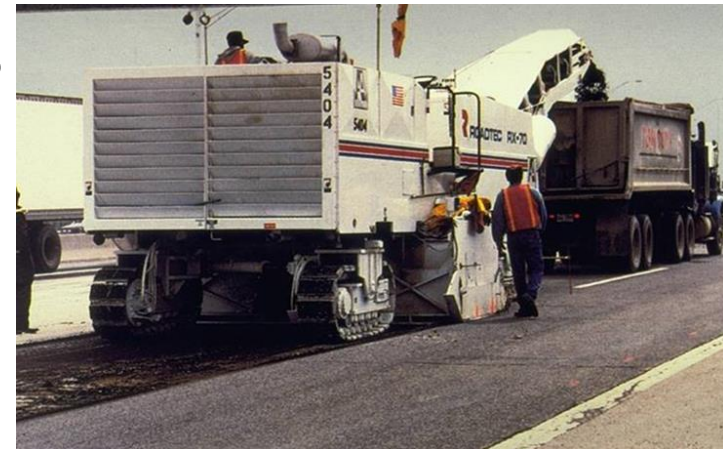
- Structural Patching or Milling
  - Many distresses that we see on the surface are a result of a deeper structural problem
  - Steps should be taken to address the source of the problem
  - Removal of all distressed layers and materials
